Historic Structure Report
OLD MAIN LIBRARY
VOLUME I

San Francisco, California

December 10, 1998
Prepared by Page & Turnbull, Inc.

Historic Structure Report
Old Main Library
Volume I

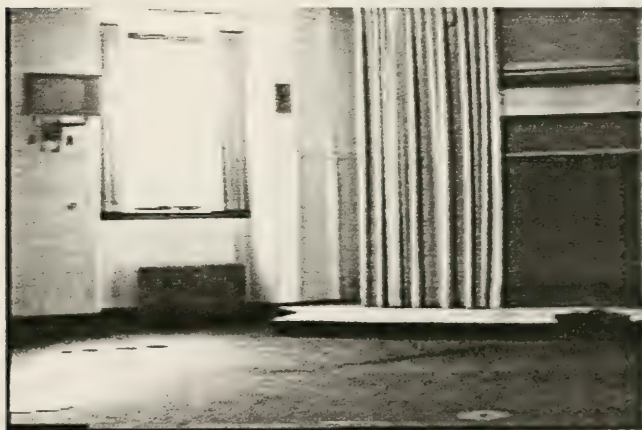
Room Name	102
Floor	First
Original Use	Room for Blind
Recent Use	Louis R. Lurie Meeting Room
Primary Features	Altered in 1974 as a public meeting room for special events; original casement windows with cremone bolts
Major Alterations	Acoustical tile in ceiling and on east wall; stage with new wall partitions; audio-visual equipment (TV, screen, projector mount in ceiling), grass weave patterned plastic wall covering in entrance foyer, carpeting, fluorescent lights
Rating	Non-contributing

Photograph 1: Room 102. Room view.

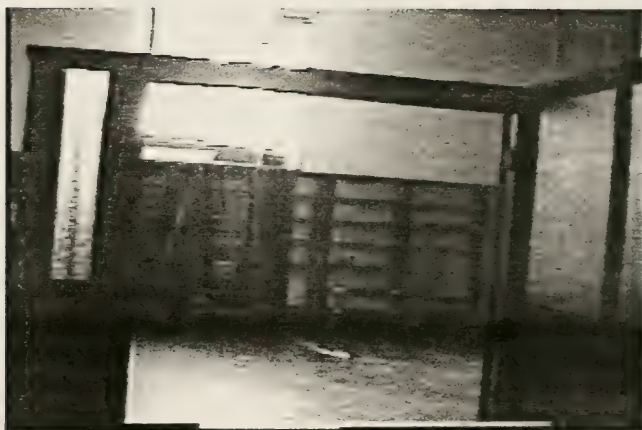
Room Name	103
Floor	First
Original Use	Branch and Station Department
Recent Use	Book Sorting to Branches
Primary Features	Large work area with utilitarian finishes; casement windows with cremone bolt
Major Alterations	Added partitions and shelving for book sorting; one cremone bolt missing
Rating	Preservation Zone 3

Photograph 1: Room 103. Room view.

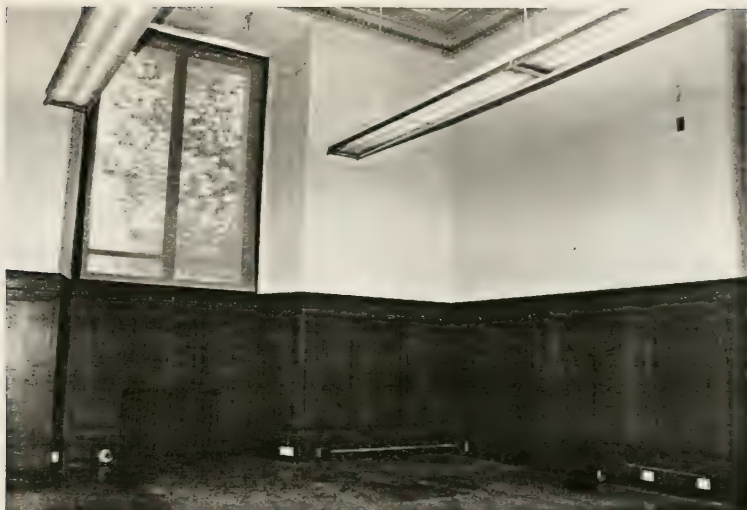
Photograph 1: Room 105. Room view.

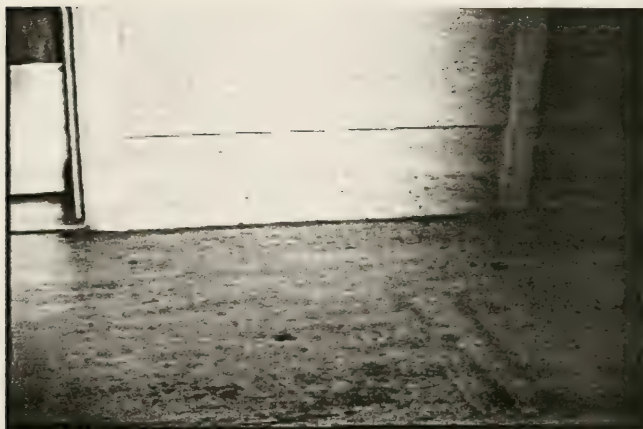
Photograph 2: Room 106. Floor and wainscot.

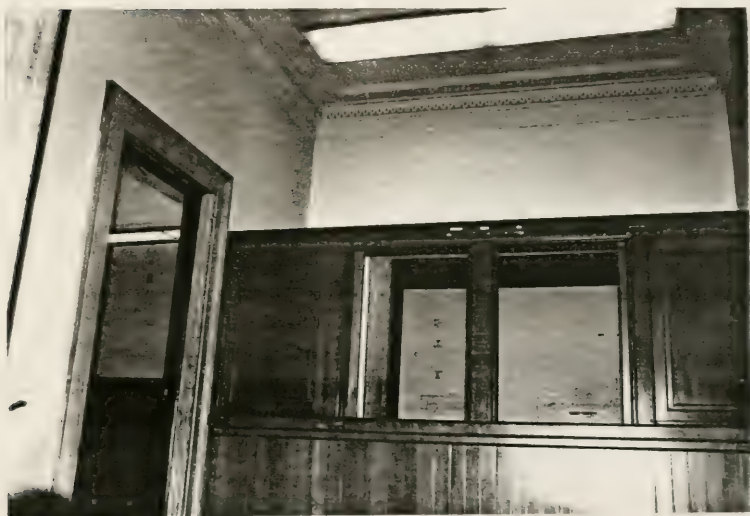
Photograph 5: Room 107A Room view.

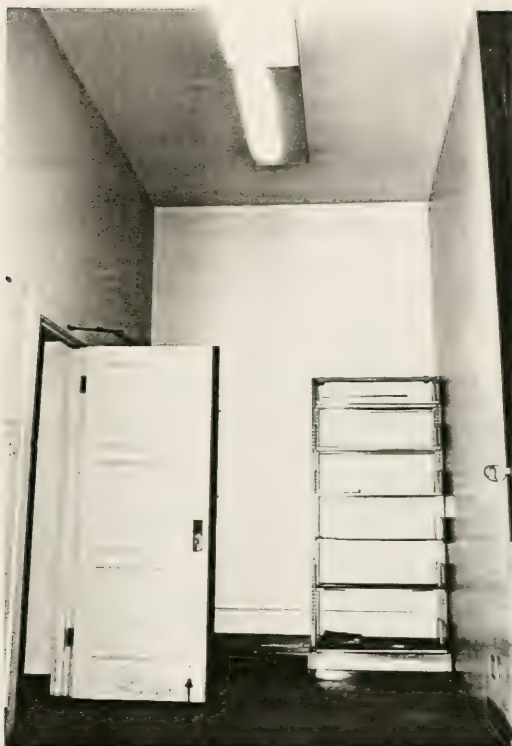
Photograph 1: Room 107B. Room view.

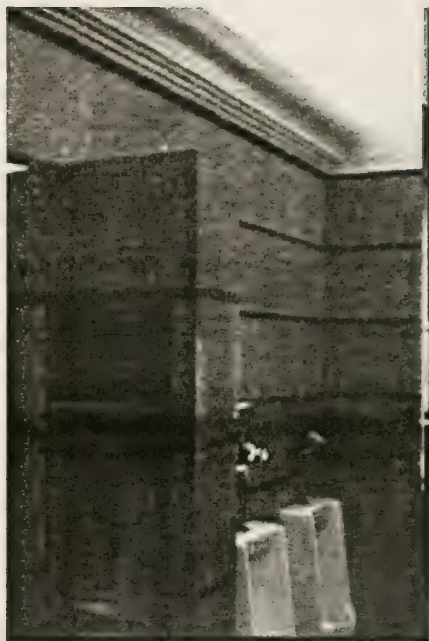
Room Name	108A, 108B, 110, 111, 113
Floor	First
Original Use	Restrooms
Recent Use	Public restrooms
Primary Features	Granite wall facing, stall partitions, and floors (all recent alterations); original double-hung wood sash windows
Major Alterations	Granite wall facing, stall partitions, and floors; profiled cornices with indirect lighting
Rating	Non-contributing

Photograph 3: Room 111 Room view.

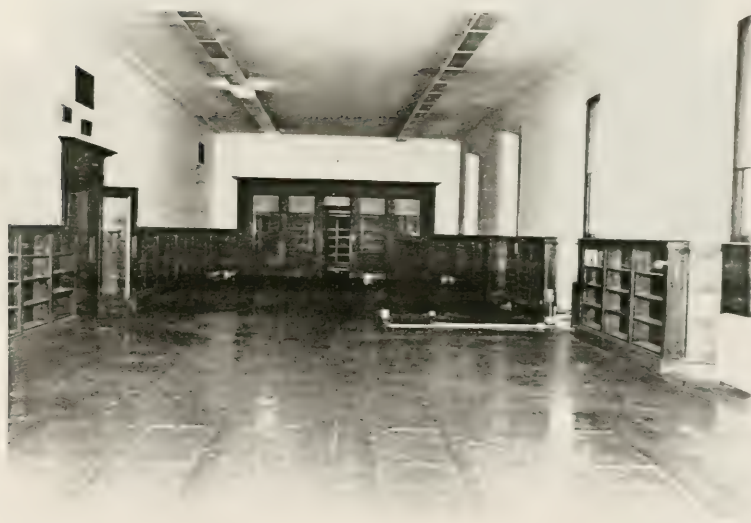
Photograph 1 Room 114 Room view looking east

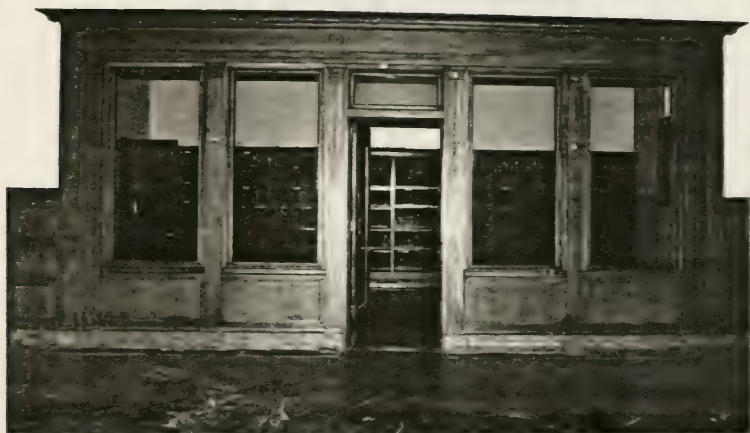
Photograph 2: Room 114. Entrance with sideights to Room 116.

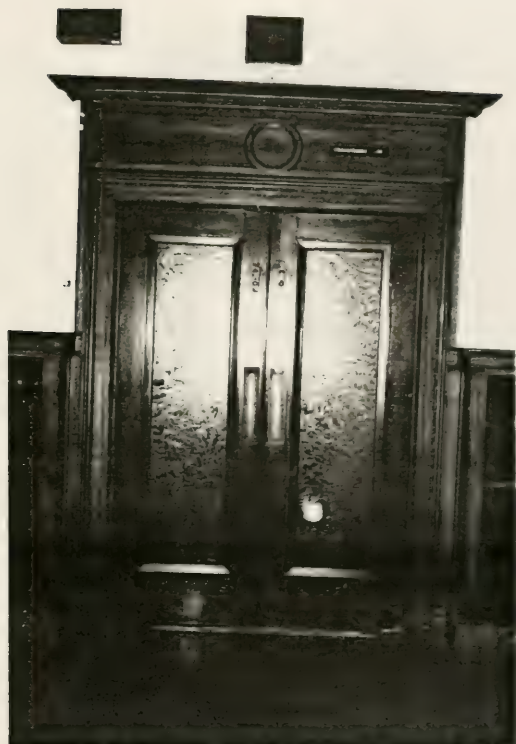
Photograph 3: Room 114. Door to Room 194.

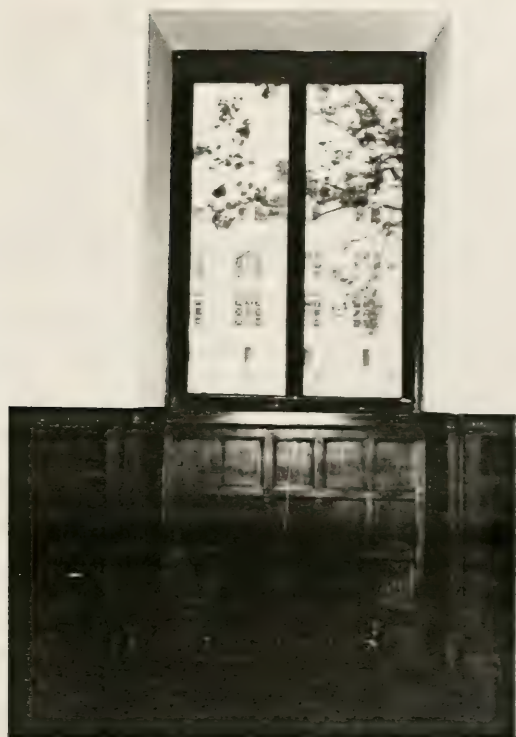
Photograph 4. Room 114 Window alcove with casement window, wainscot, and radiator

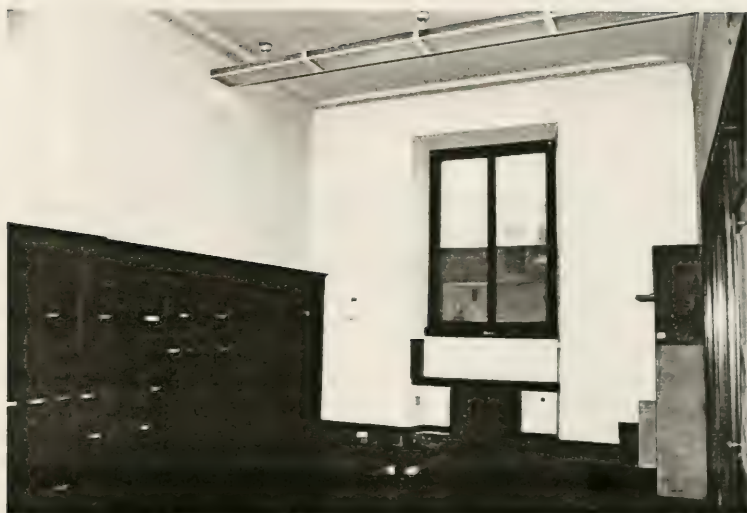
Photograph 1: Room 116. Room view

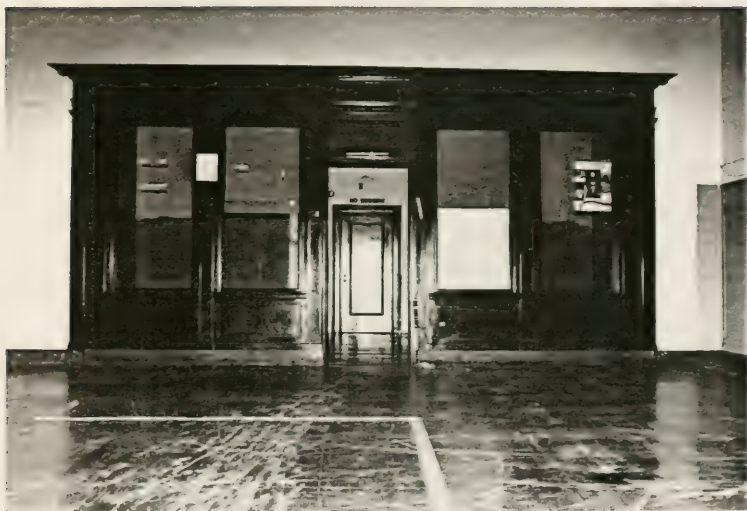
Photograph 2: Room 118. Entrance to Room 118B.

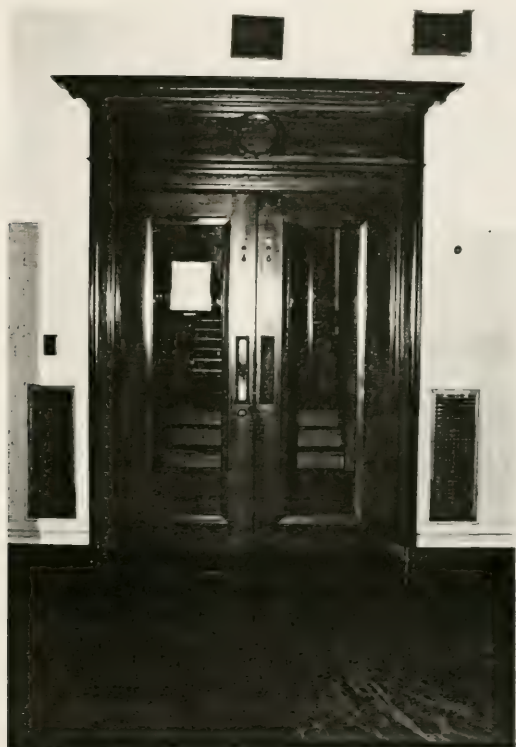
Photograph 3: Room 118, Door to Corridor 194.

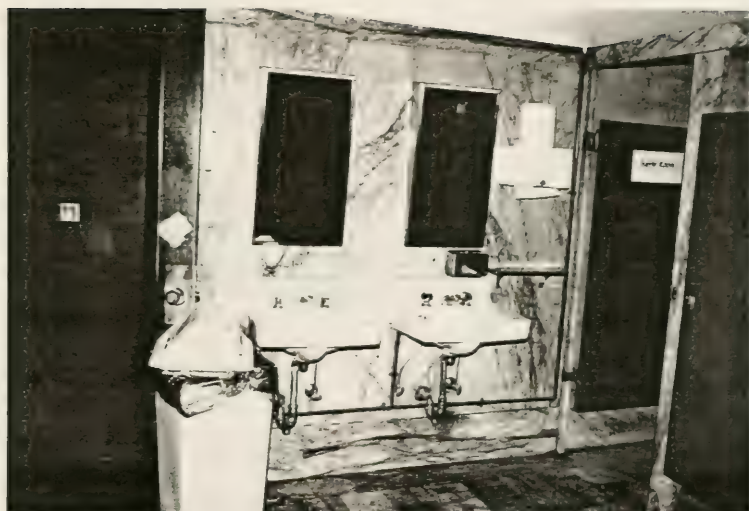
Photograph 1: Room 122. Room view.

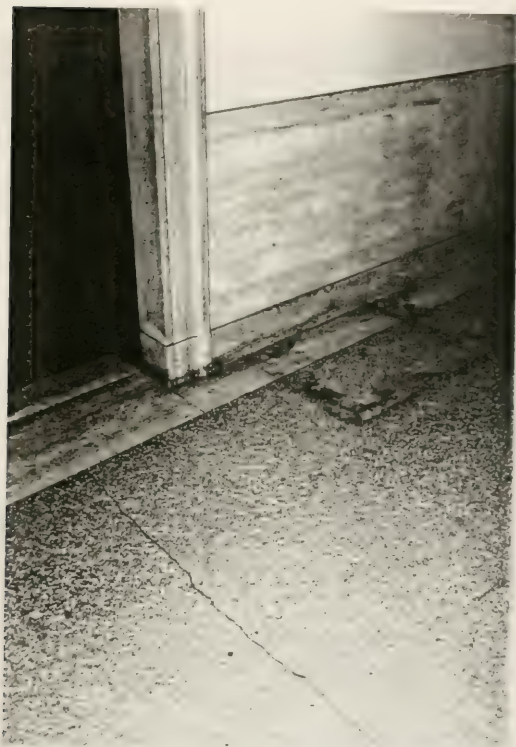
Photograph 2: Room 194. Detail of terrazzo floor, travertine border, travertine wainscot, and travertine door casing.

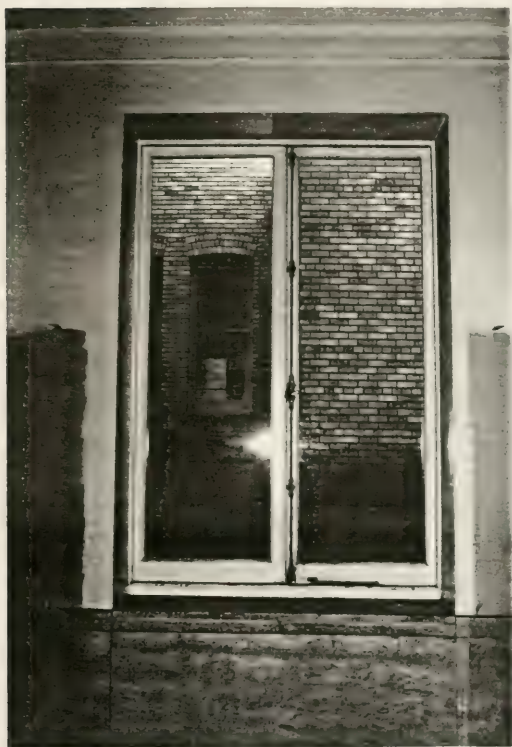
Photograph 3: Room 194. Paired casement window with cremone bolt.

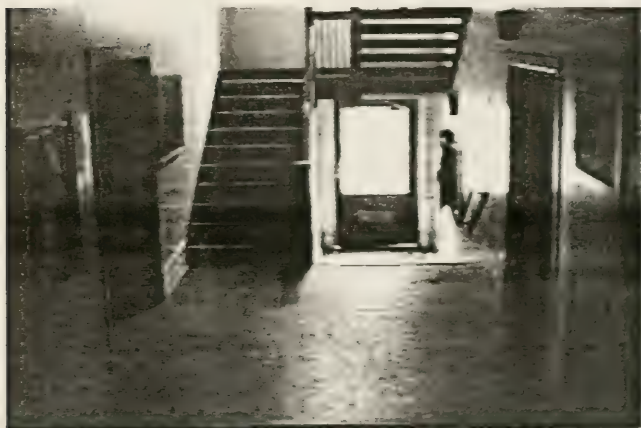
Photograph 5. Room 107. Room view.

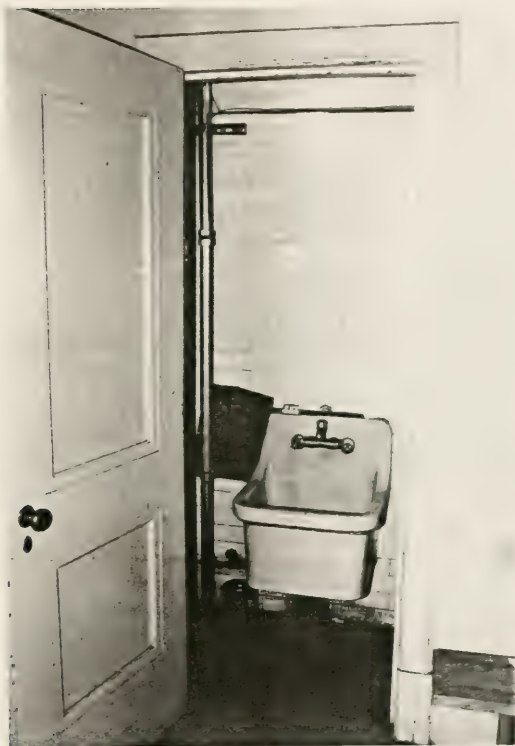
Photograph 1: Room 197A View from Room 197

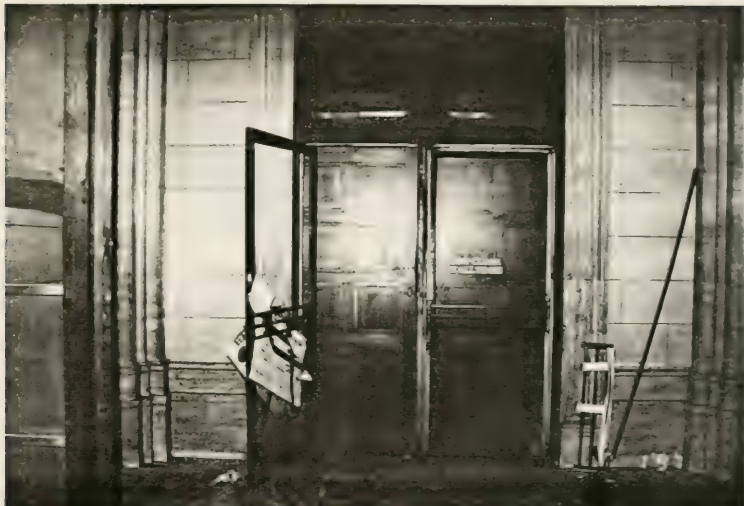
Photograph 3: Room 198A. Door to Fulton Street.

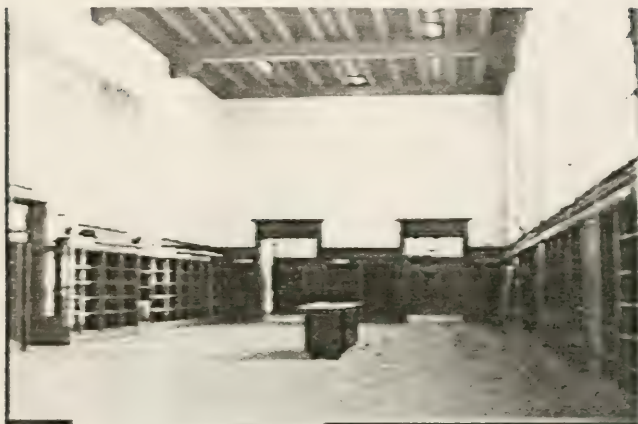
Photograph 1: Room 201. Room view, looking south.

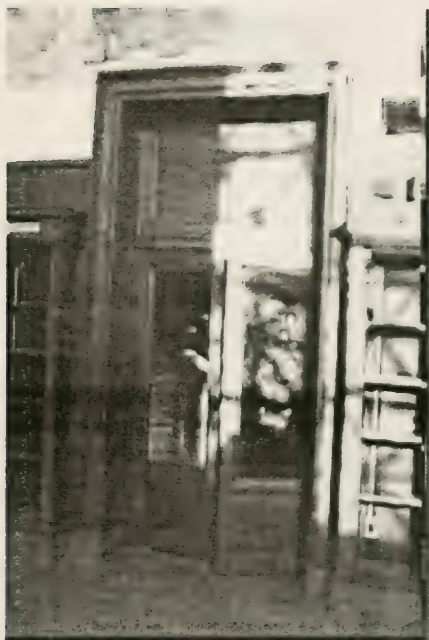
Photograph 3: Room 201. Door to Room 291A.

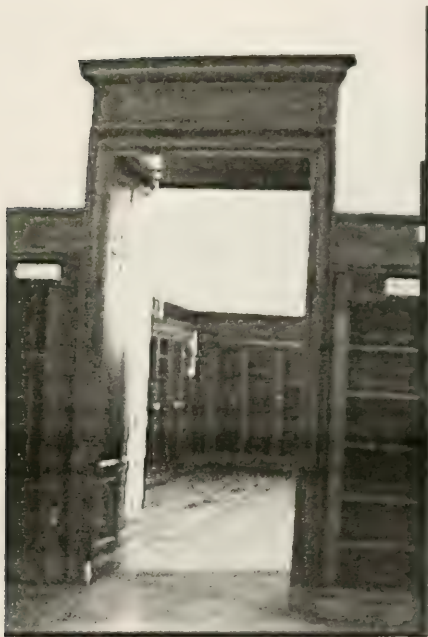
Photograph 4: Room 201. Door to Room 202.

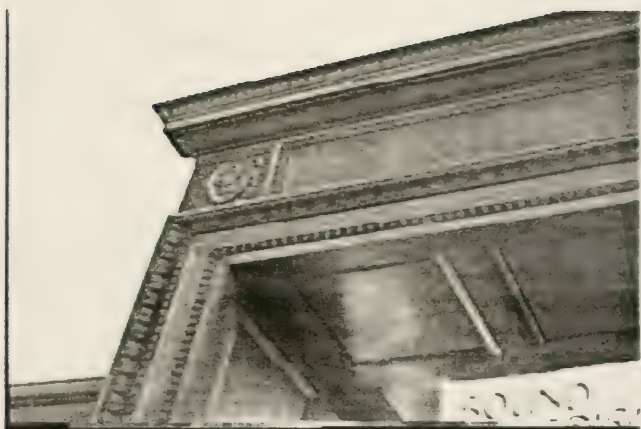
Photograph 5: Room 201. Detail of door to Room 202.

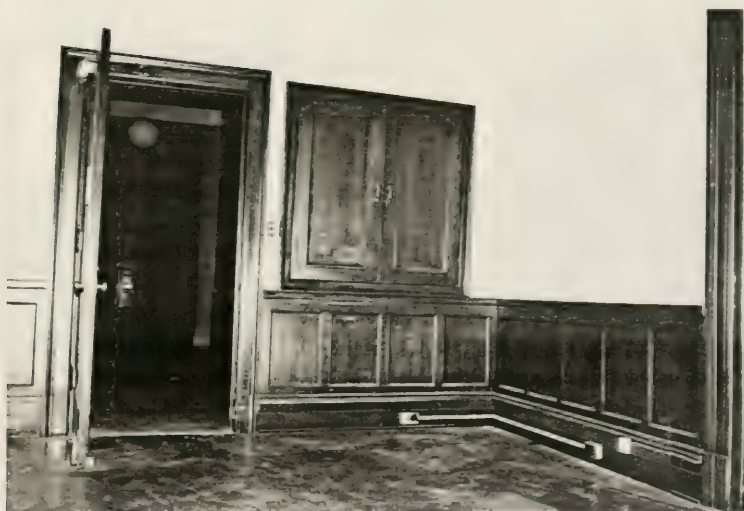
Photograph 1: Room 204. Room view looking north.

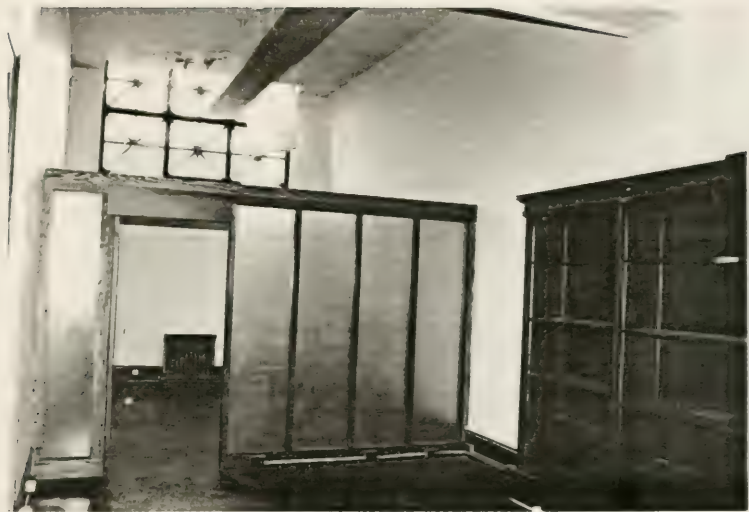
Photograph 2: Room 204. Room view looking south.

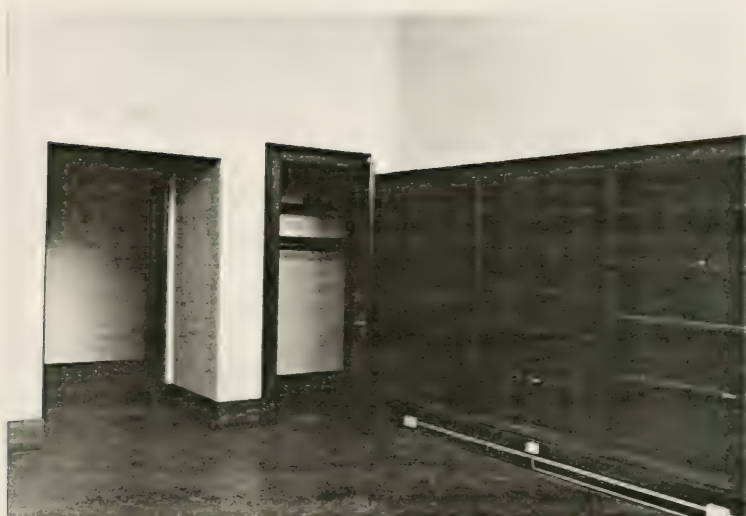
Photograph 3: Room 206. Room view.

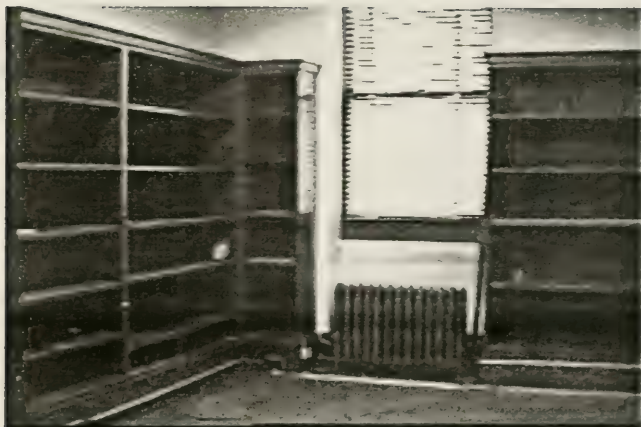
Photograph 1: Room 207. Room view

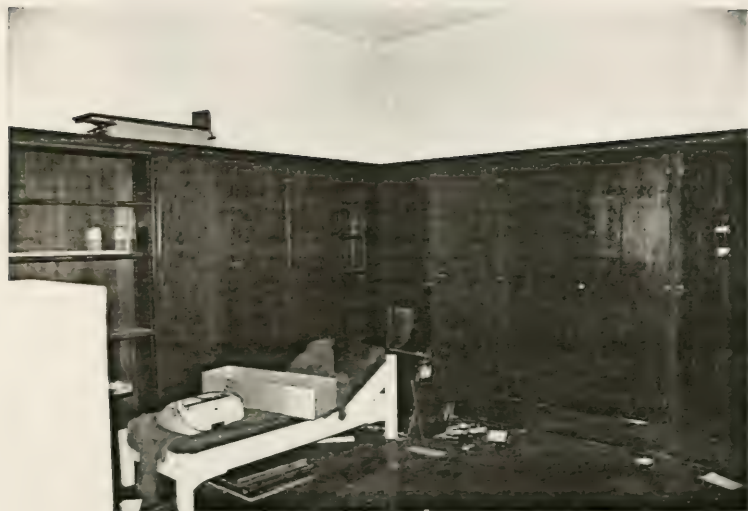
Postscript 2: Room 209. Room view.

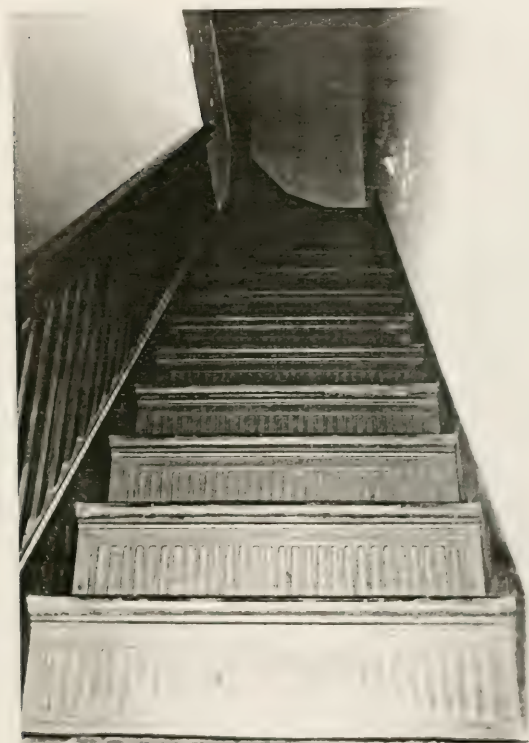
Plate 129: Staircase from Room 207 to Room 209

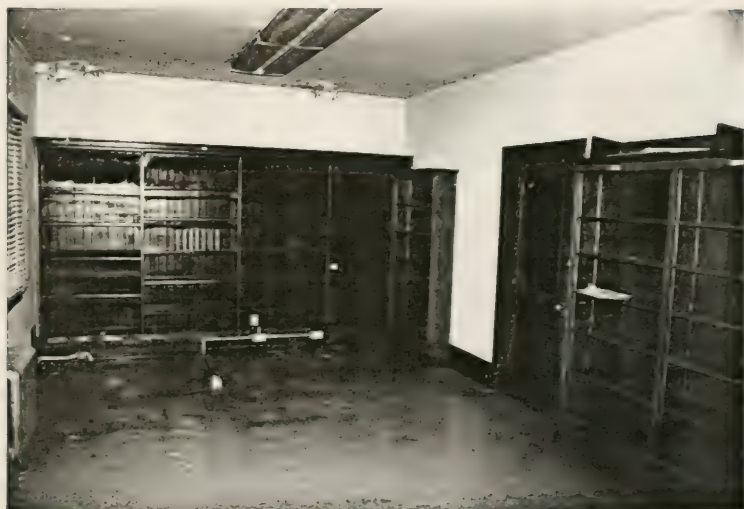
Photograph 1: Room 213. Room view looking north.

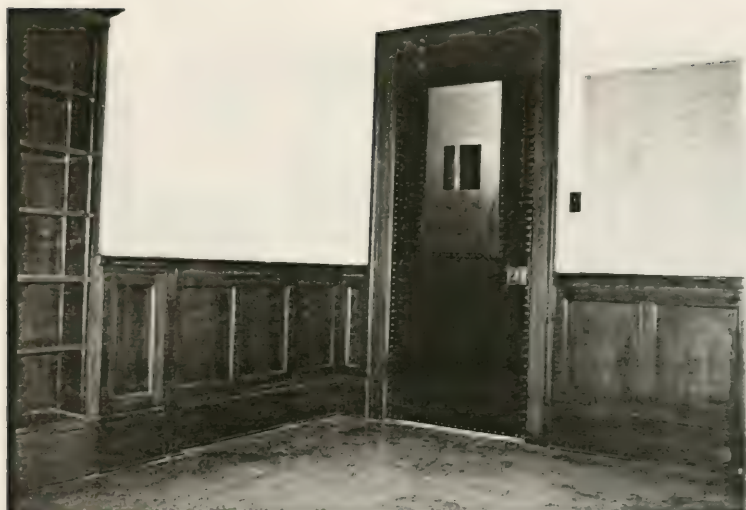
Photograph 2: Room 213. Detail of wainscot and leather-covered door.

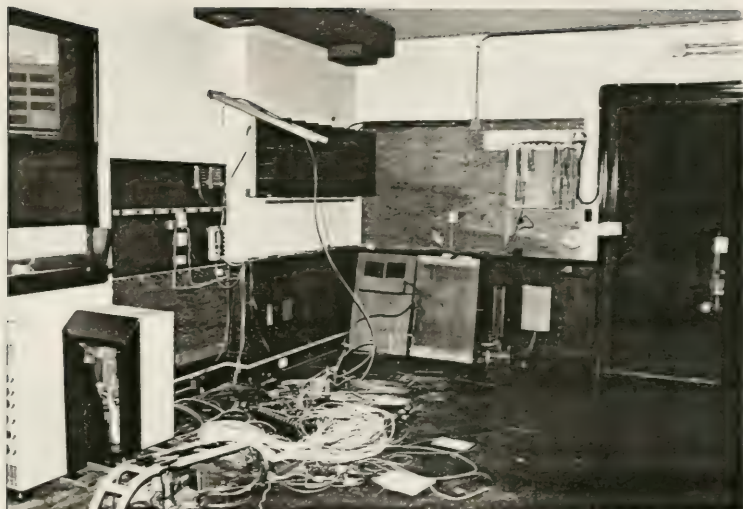
Photograph of Room 217. Room view.

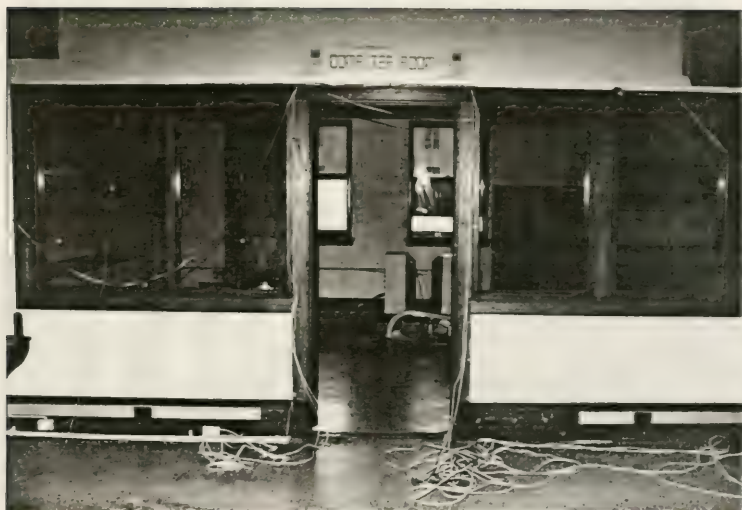
Photograph 4: Room 211. Doorway and sidelights to Room 217.

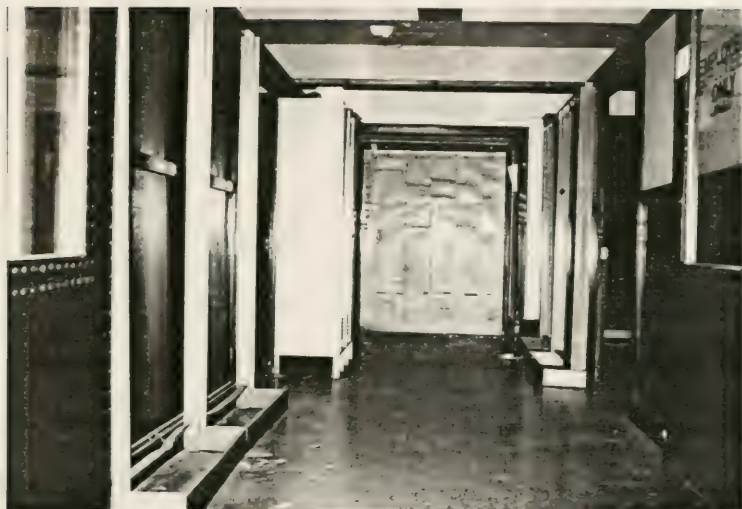
Photograph 5: Room 211: Central corridor formed by partitions

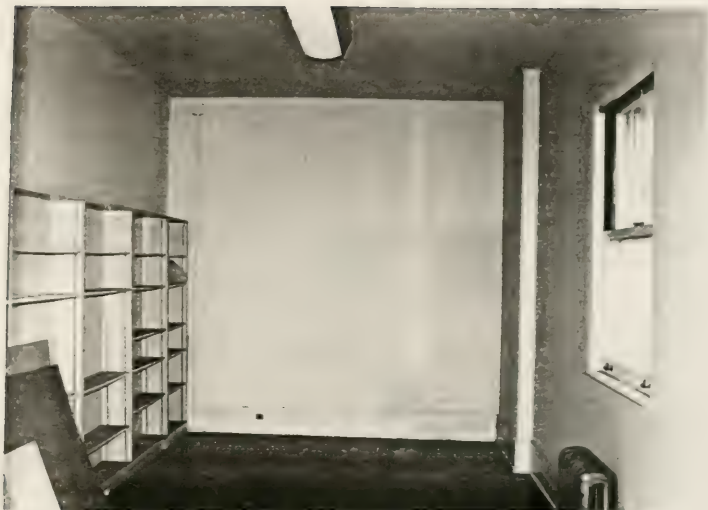
Photograph 1: Room 216. Room view.

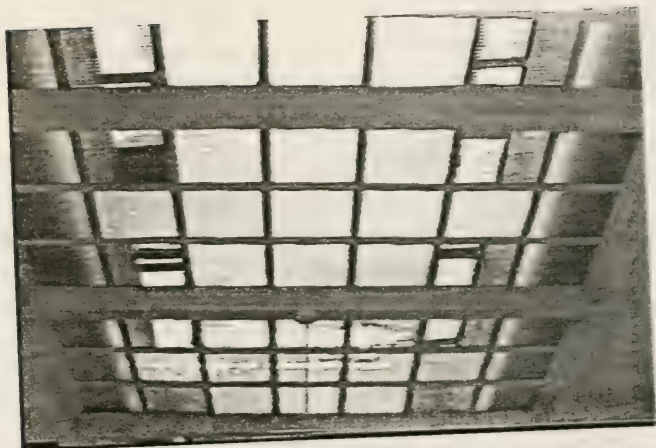
Lighting	
Design	uniform grid
Material	metal grilles, glass
Condition	poor
Significance	significant

Photograph 3. Room 301. Laylights.

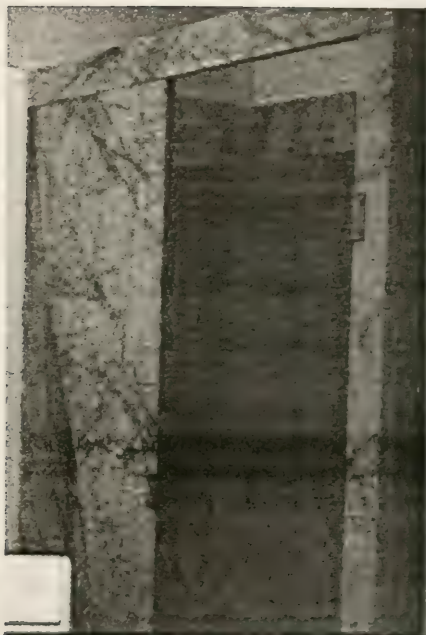
Photograph 1. Rooms 308 Toilet stall partition.

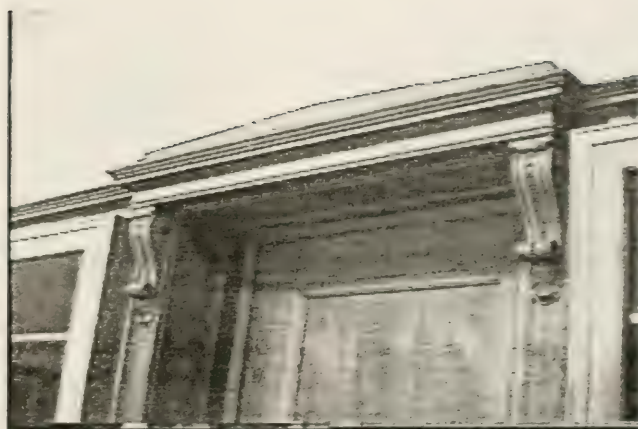
Photograph 2 Room 318D. Door, pediment and brackets

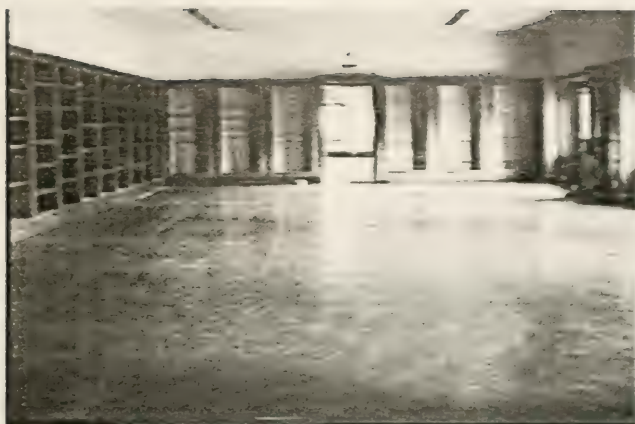
Photograph 1 Room 320 Room view

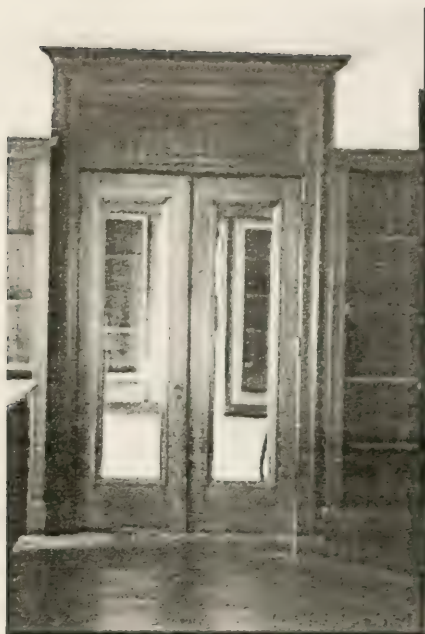
Photograph 4: Room 320. Door to Room 318D.

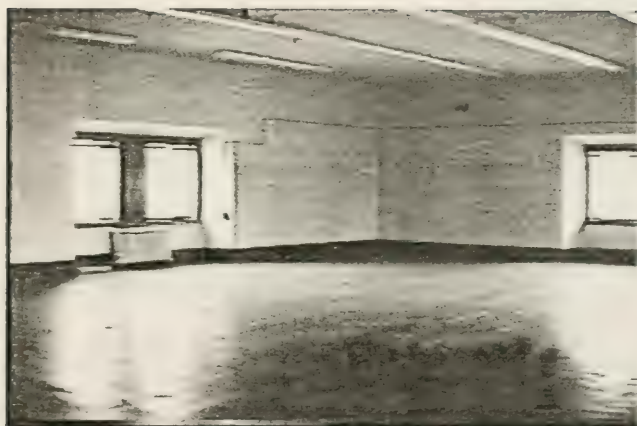
Photograph of Rooms 322-324, Room 322.

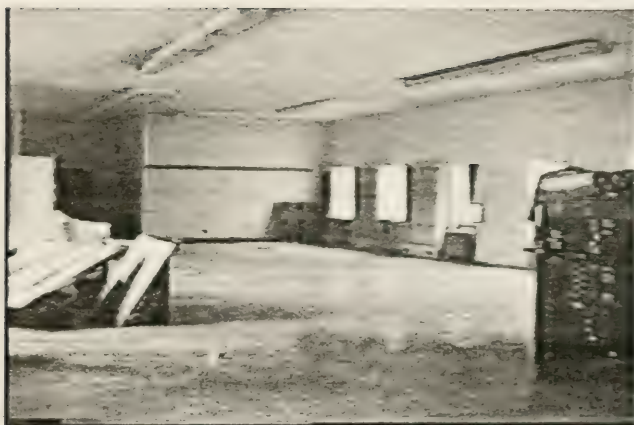
Photograph of Room 325 Room view

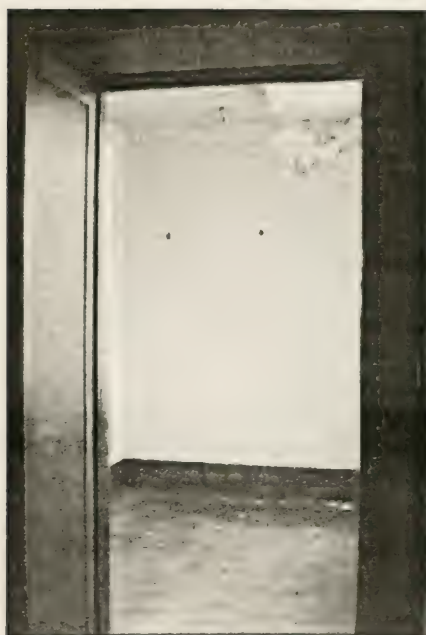
Photograph 1: Room 326. Room view, from Corridor 3/2A

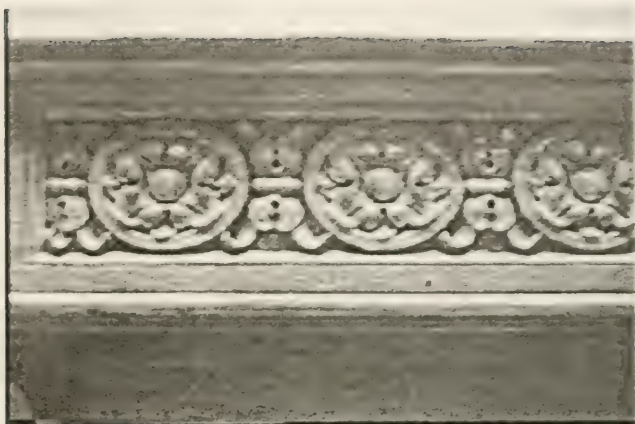
Photograph 2 Room 390 Detail of display case ornament

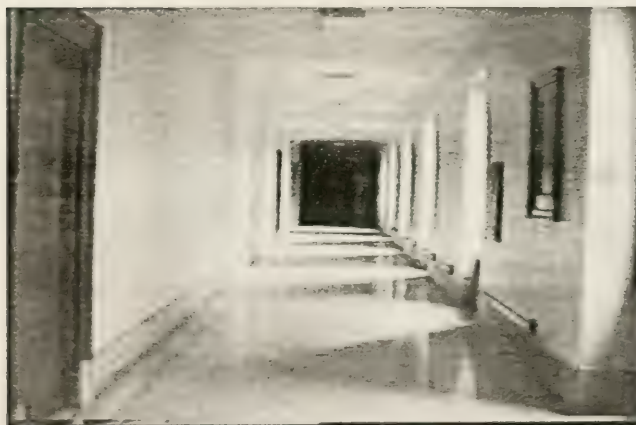
Photograph 1. Room 302 Corridor view

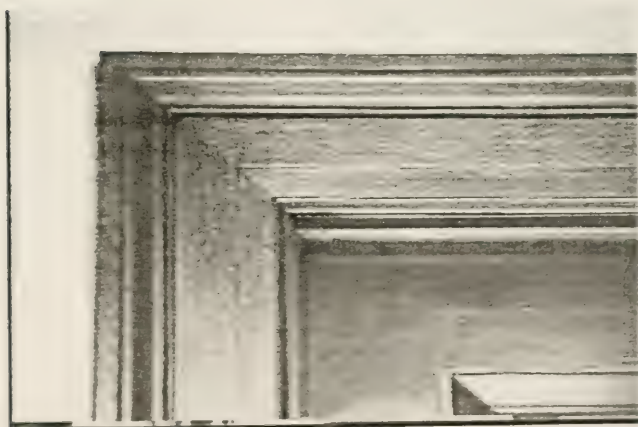
Photograph 3: Room 392. Typical doorway.

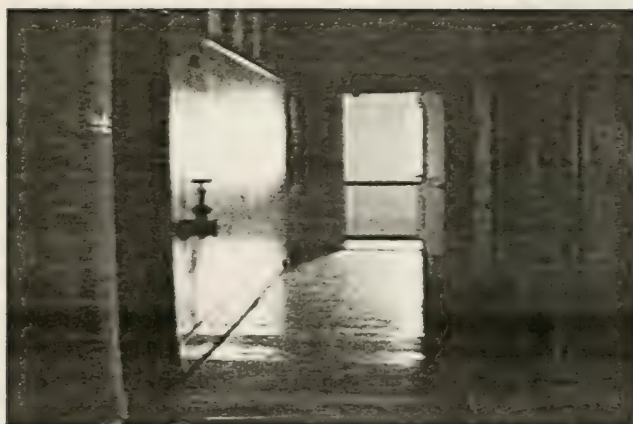
Photograph 1 Room 393 interior view

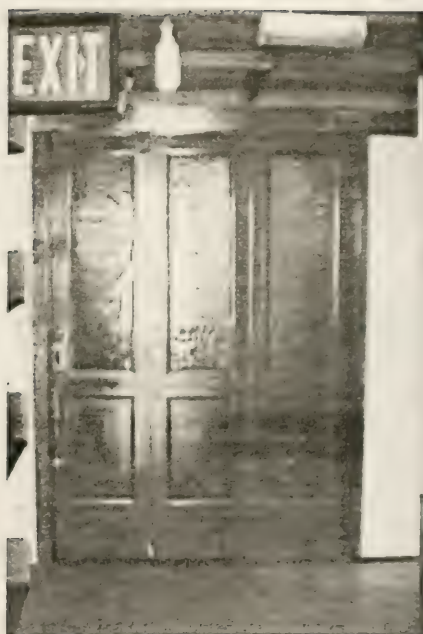
Figure 1: Exit Sign

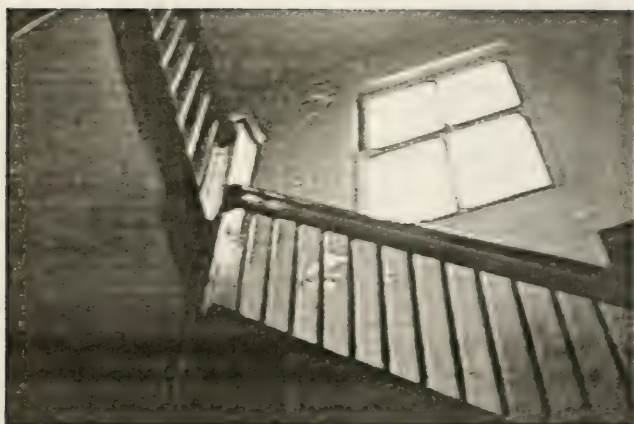
Figure 1: Stair S/W View up stair
